FEMA-DR-4399-FL

SITE INSPECTION MITIGATION REPORT FIRST UNITED METHODIST CHURCH OF PORT ST. JOE

Type: WO# 38351
Applicant: First United Methodist Church of Port St. Joe FIPS#: 045-12767-00
County: Gulf
Site: Historic Triangle Park
Date: 05/28/2019
Location: 1001 Constitution Drive, Port St. Joe, FL 32456
Lat/Long: Refer to Site Inspection Report
Attendees: Refer to PA Grants Manager for list of attendees

DI# 248755 Category: G 0 % work complete

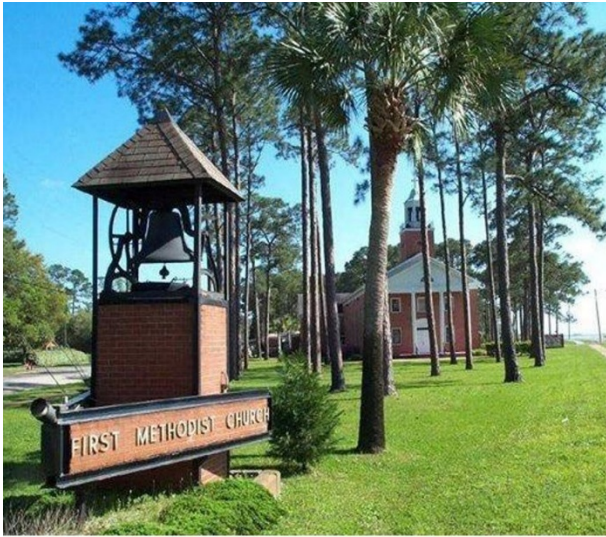
Photo 1: Trees and landscaping at Triangle Park (pre-Hurricane Michael). Refer to SIR for Lat/Long (typ).

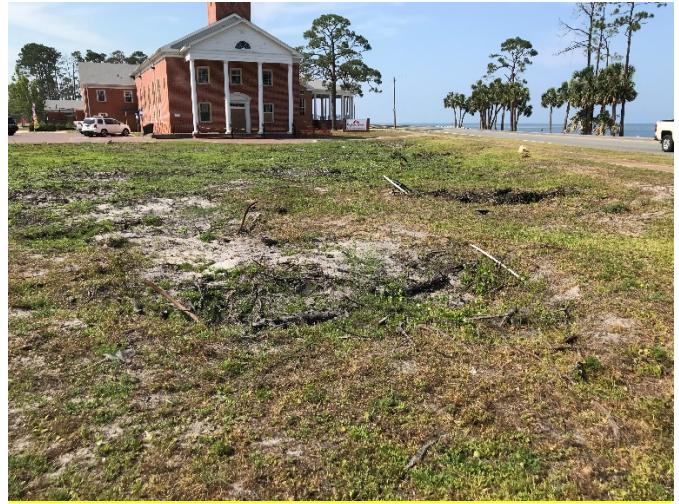
This DI consists of both aboveground and subsurface damages at Triangle Park. Aboveground damages include a dislodged (leaning) flagpole, the complete loss of numerous mature pine trees, corrosion and other impacts to the historic bell tower monument, loss of benches, and ground surface erosion. Subsurface damages include destruction to all components of the irrigation system network (buried 1¼" PVC pipe, distribution appurtenances, pump and motor in base of bell tower monument) and the drainage system network (~4" diameter corrugated plastic drain piping and both metal and plastic drain grates).

Photo 2: Condition of Triangle Park at time of site inspection.

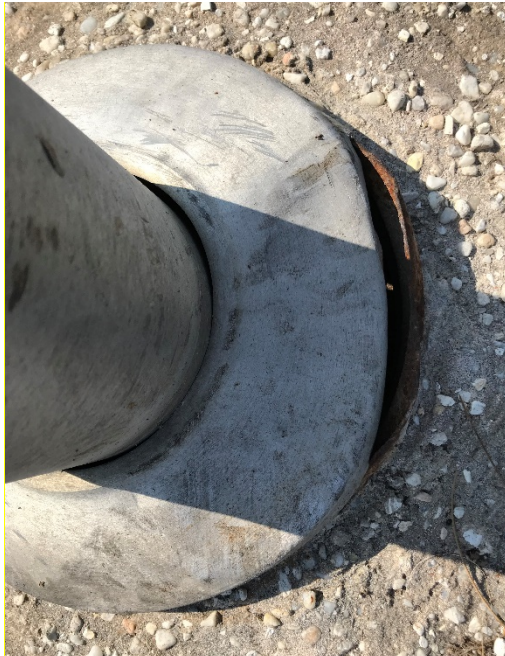
Photo 3: Dislodged flagpole base.

- Providing a more secure embedment system for the flagpole when it is reset.
- Repairing or replacing damaged ornamental and structural metal components at the historic bell tower monument with corrosion-resistant coatings and materials.
- To mitigate against a similar recurrence regarding any benches at Triangle Park that were lost due to the storm surge, consideration should be given to anchoring these benches to a concrete slab; given the proximity to St. Joseph Bay, stainless steel fasteners should be used.

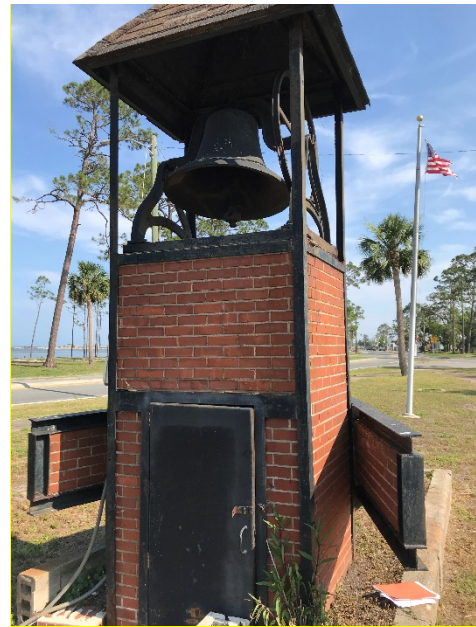
Photo 4: Historic bell tower monument.

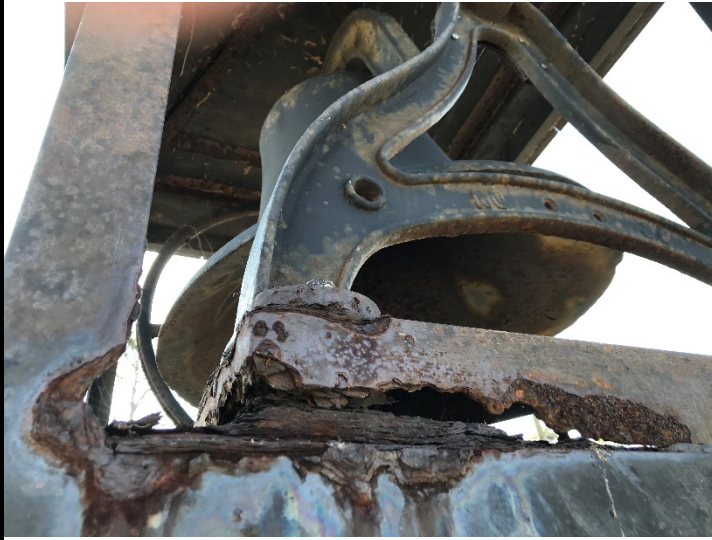
Photo 5: Corrosion severely exacerbated by Hurricane Michael.

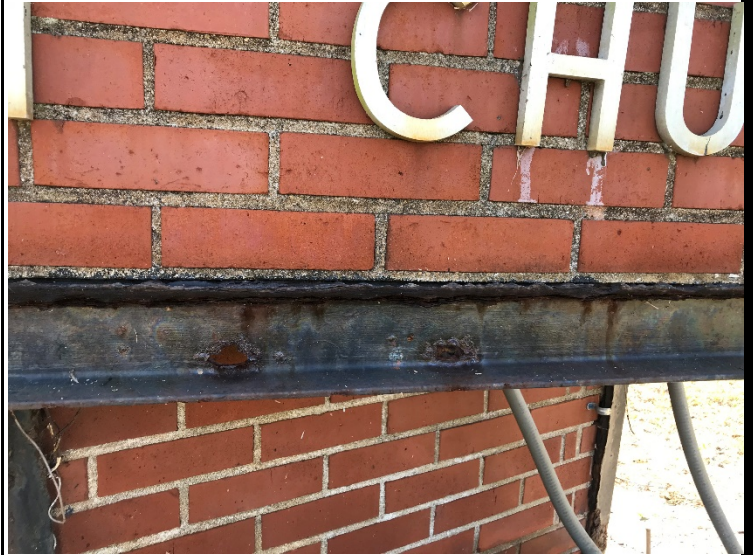
Photo 6: Additional example of corrosion at bell tower monument.

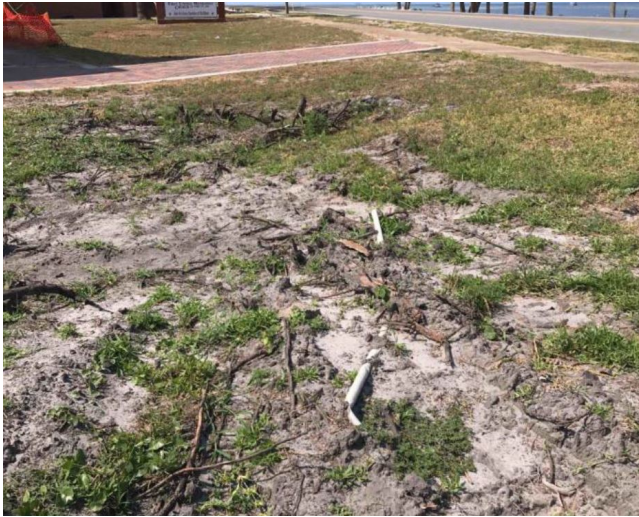
Photo 7: Remnant of destroyed irrigation system.

- It is impractical to restore the lost mature trees in a timely manner.
- Given the changed vegetative characteristics of Triangle Park because of Hurricane Michael, a different irrigation system is probably warranted, but any redesign would not have a mitigation component that could be prescribed.

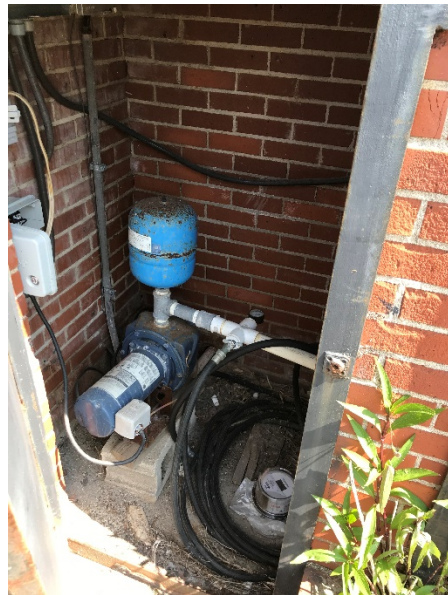
Photo 8: Destroyed irrigation system pump and motor.

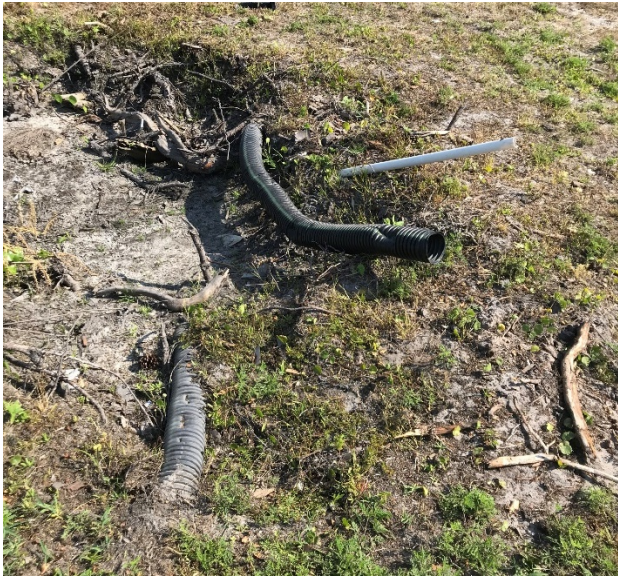
- The most complex damage at Triangle Park, both physically and administratively, is the drainage system. Formerly a modest drainage system coupled with numerous mature pines functioned to adequately address drainage and erosion concerns at Triangle Park. With the loss of trees and ground cover due to Hurricane Michael winds and storm surge, coupled with the complete destruction of the drainage system due to uprooted trees, an entirely new approach must be developed that will most likely require significant FEMA EHP involvement and an engineered solution. Applicant envisions that such a solution could entail regrading Triangle Park, constructing new drainage structures and conveyance pipes, and installing a pump to transfer collected drainage to the water retention pond; damage issues associated with the water retention pond are being documented under DI# 248732, but the additional flows that may be received in the future from Triangle Park could require enlarging the existing retention pond. Until the myriad

Photo 9: Portion of damaged drainage and irrigation systems.

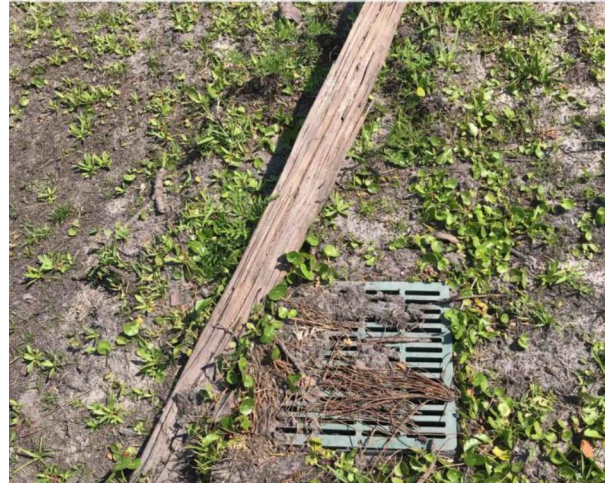
Photo 10: Plastic drain grate.

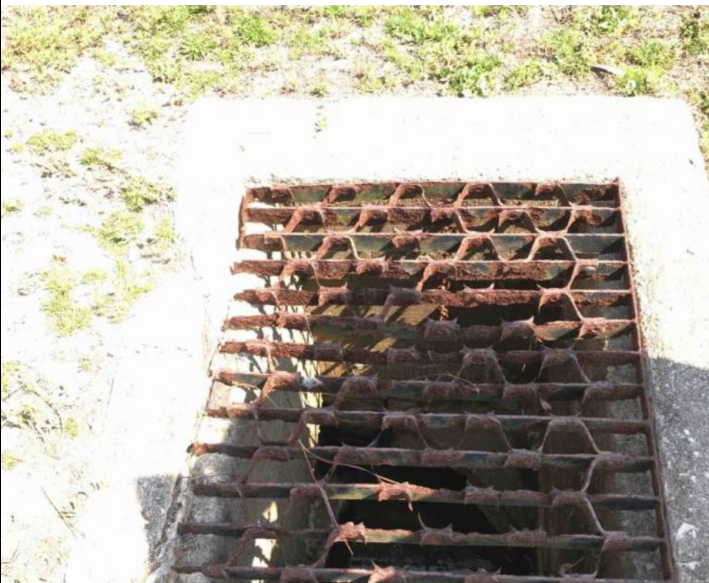
Photo 11: Metal grate drainage structure – connects to off-property drainage collection system.
